WRDC-TR-90-2120

INVESTIGATION INTO THE FAILURE CAUSE OF A
DOUBLE ACTING, LEADING EDGE GROOVE,
TILTING PAD THRUST BEARING

October 1990

AERO PROPULSION AND POWER LABORATORY
WRIGHT RESEARCH AND DEVELOPMENT CENTER
AIR FORCE SYSTEMS COMMAND
WRIGHT-PATTERSON AIR FORCE BASE, OHIO 45433-6563

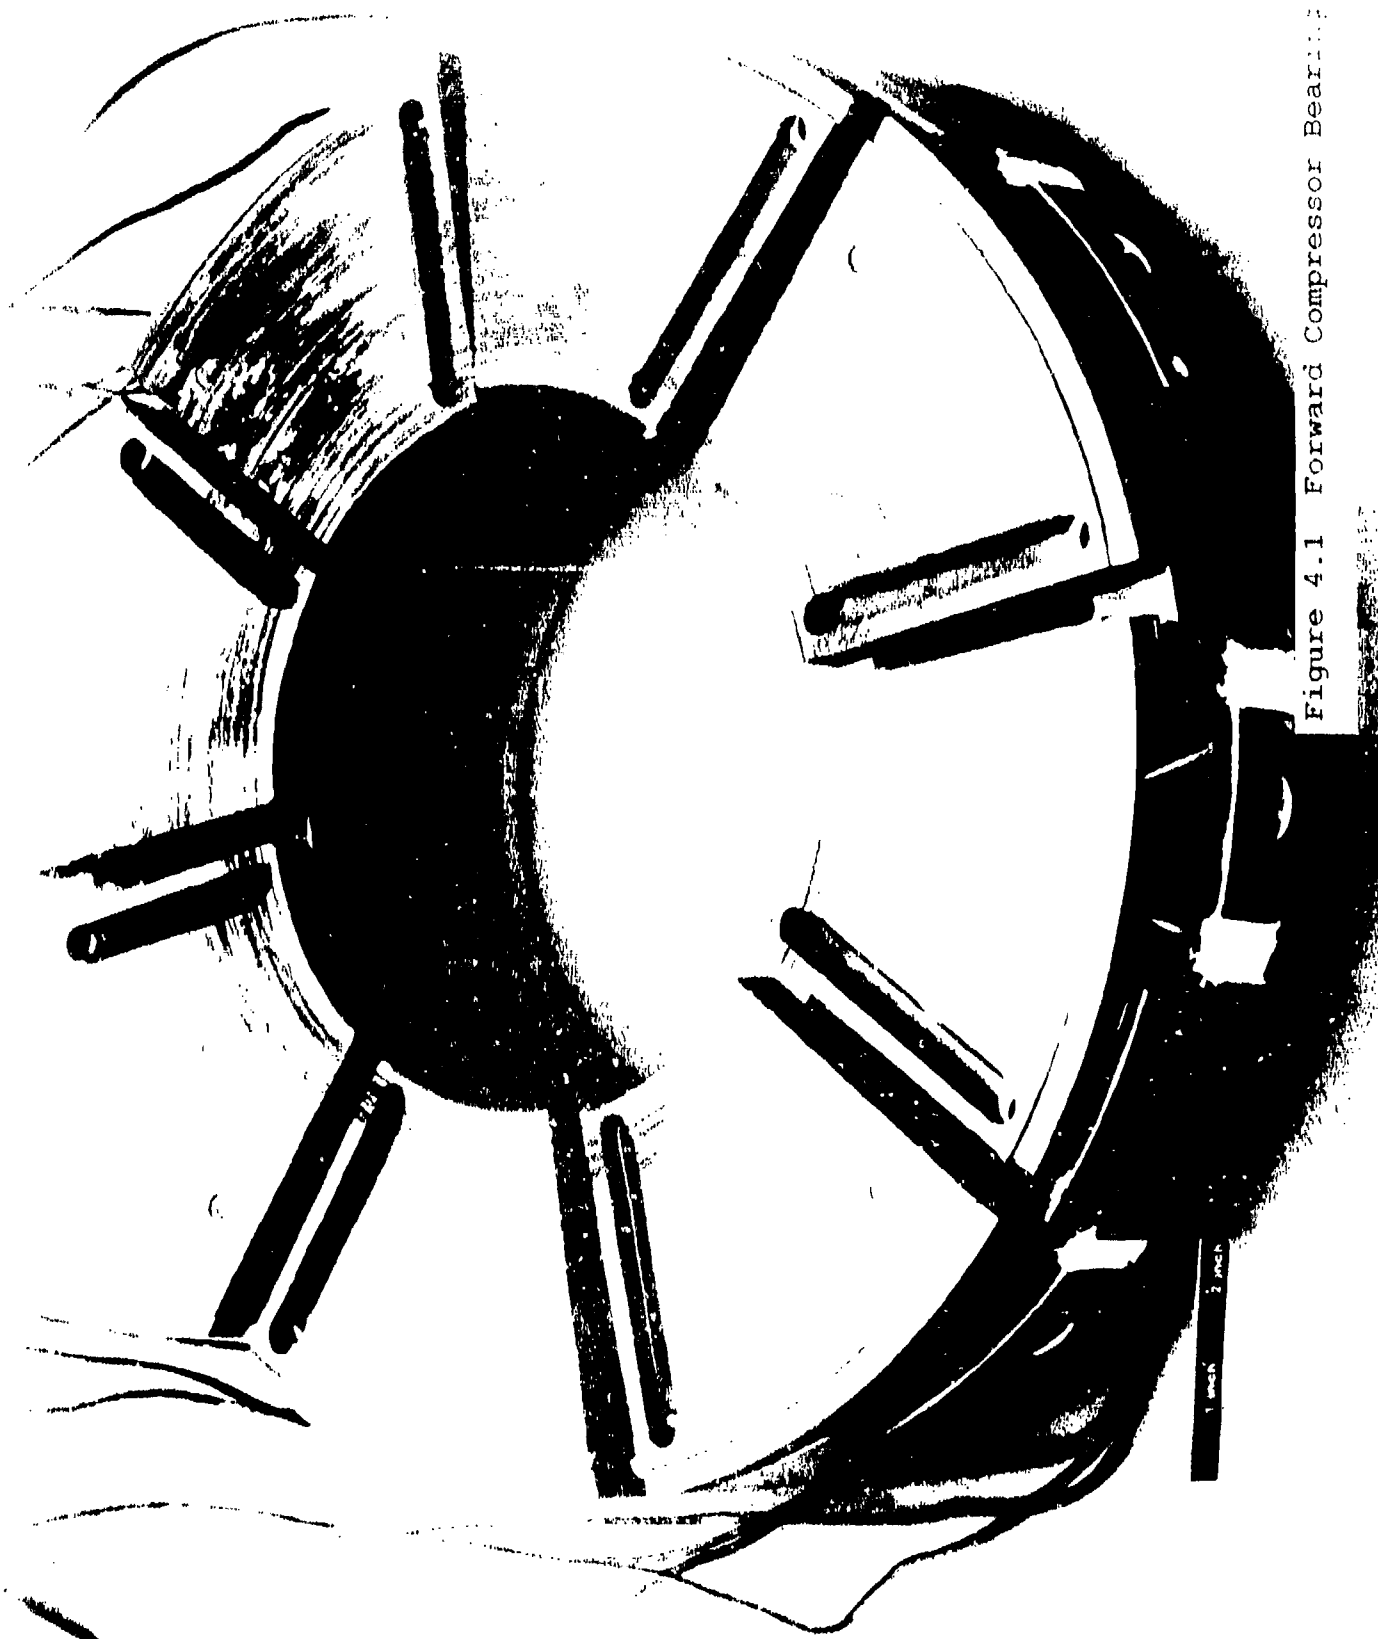
Figure 4.1 Forward Compressor Bearing

As shown in Figure 4.1, damage to the forward bearing pads was extensive, resulting in the complete loss of babbitt material on all bearing pads and destruction of all evidence of the failure cause. More information on the failure cause was available from the rear pads. Evidence of scoring and galling was apparent on the rear pads shown in Figure 4.2. Scoring is evident on the forward and rear sides of the titanium thrust collar as shown in Figures 4.3a and 4.3b, respectively.

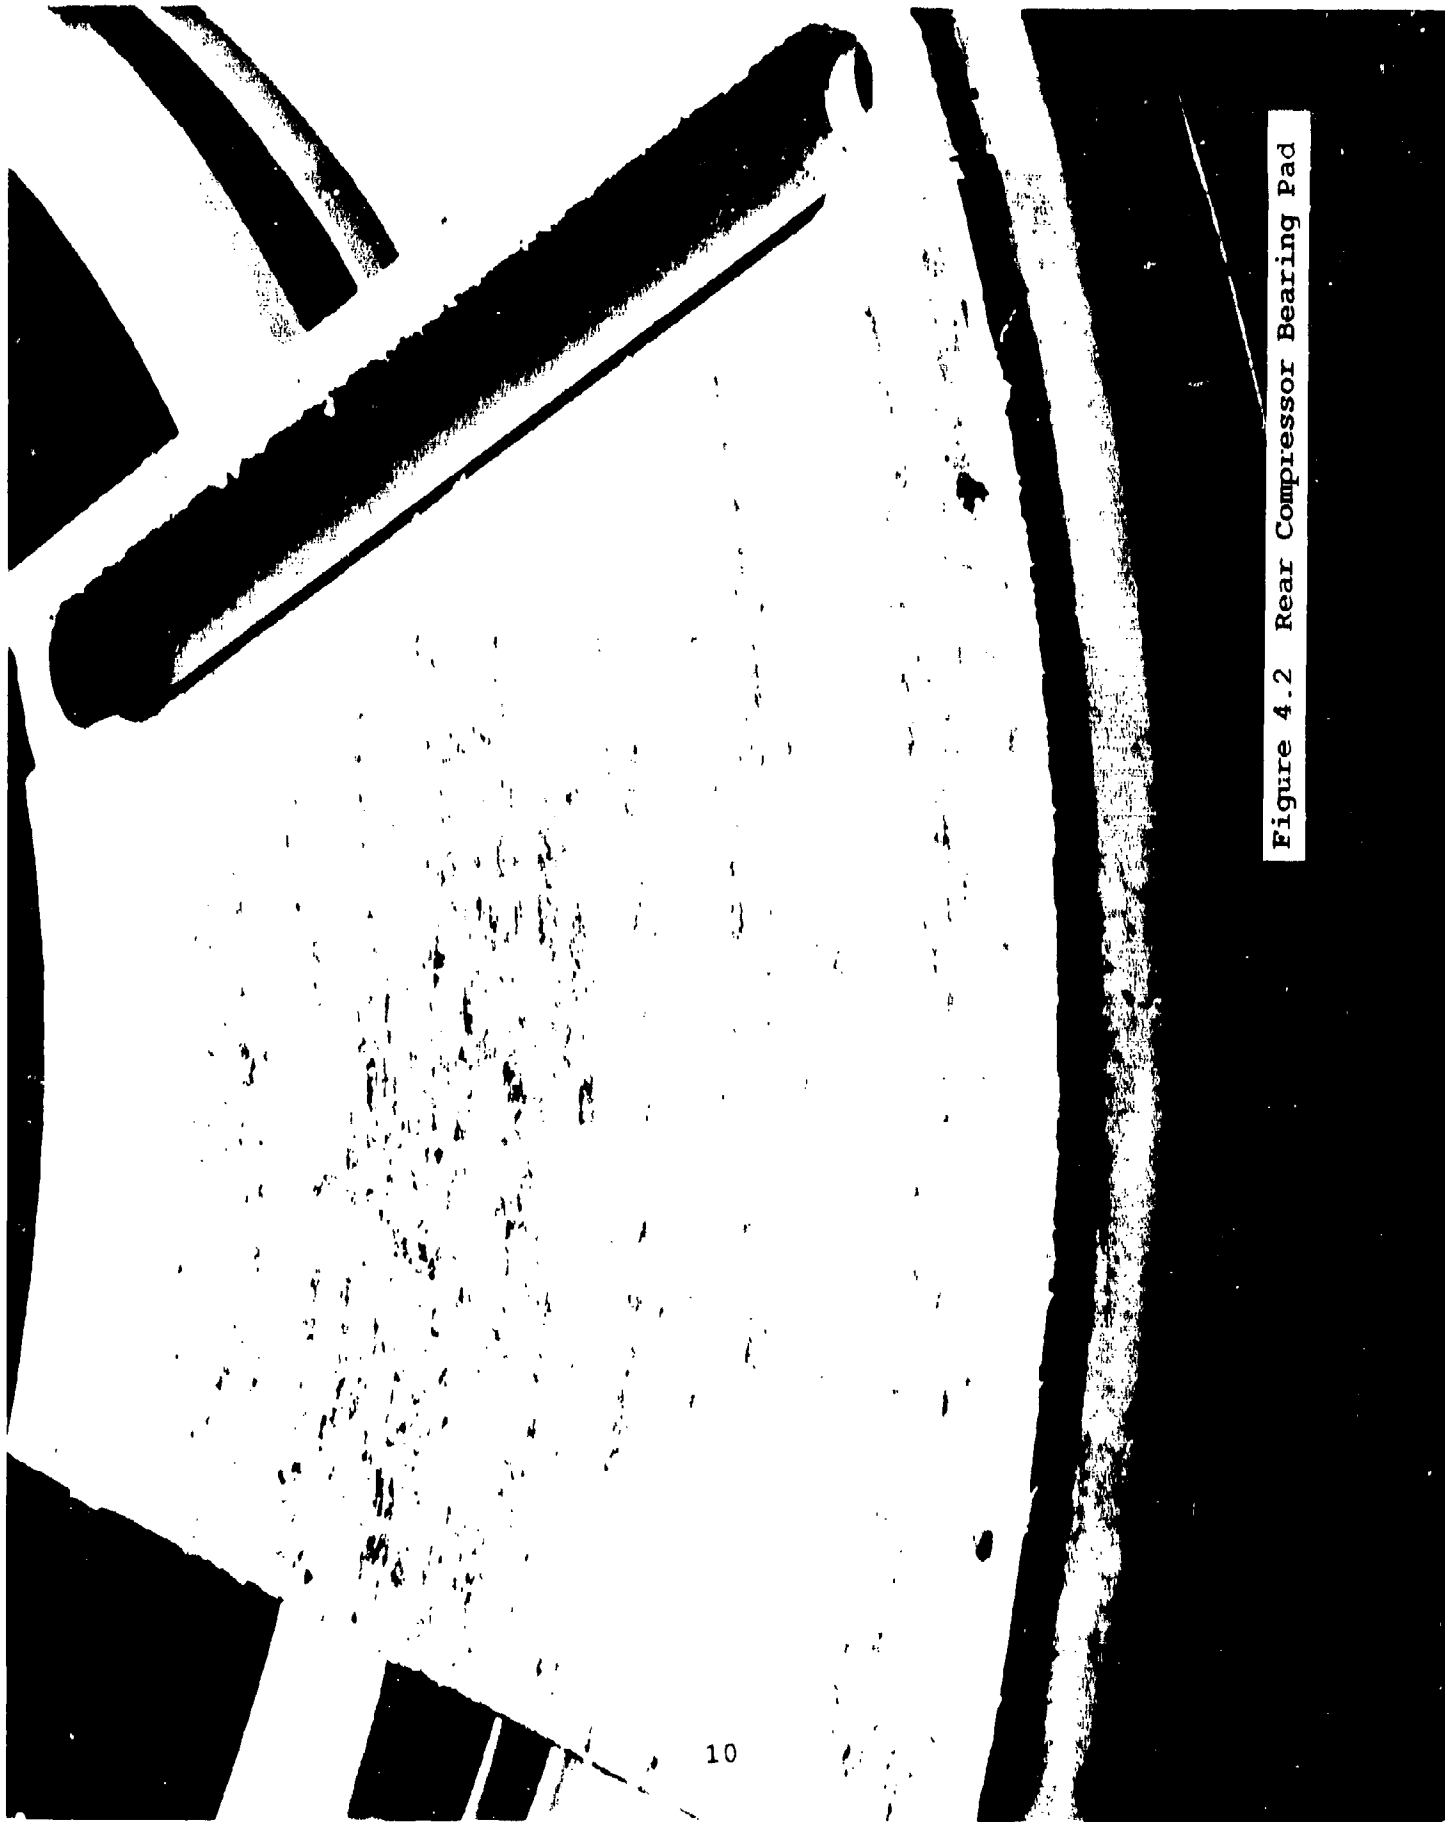
Figure 4.2 Rear Compressor Bearing Pad

The bench tests produced results similar to those found in the compressor bearing failure. Comparison of the compressor bearing rear pads in Figure 4.2 and the pad tested in bench test 1 in Figure 4.10c indicate similar failure modes. The three failure modes, galling, smearing, and abrasion are present in each pad.

The primary difference between the compressor bearing failure and bench tests 1 and 3 is the relative locations of the abrasive and galling failure zones. In the compressor bearing pad of Figure 4.2 the area of abrasion by wear particles precedes the area of adhesive damage and galling. In the bearing pad from the bench test, the relative locations of the areas are reversed. The pressurized oil source, leading edge groove and offset pivot of the compressor bearing would create an improved lift off of the leading edge and relatively smaller gap between pad trailing edge and collar. These conditions could not be duplicated in the bench tests and probably resulted in the differences in the relative locations of the failure mode zones.

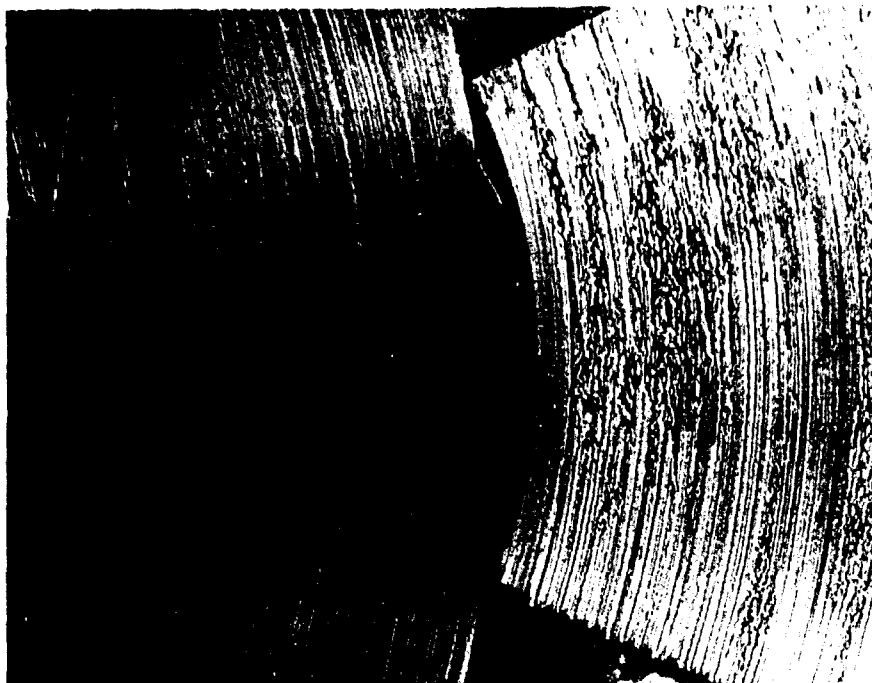
Figure 4.11 Collar and Pad After Bench Test_1

Figure 4.11 shows the titanium collar next to the bearing pad. The collar exhibited deep, circumferential wear grooves. The collar surface revealed small, raised oval and rectangular shaped surfaces, approximately 0.005 by 0.020 inches in size. A sample of these was scraped off of the collar surface and the composition was determined to be primarily tin, with traces of titanium and aluminum.

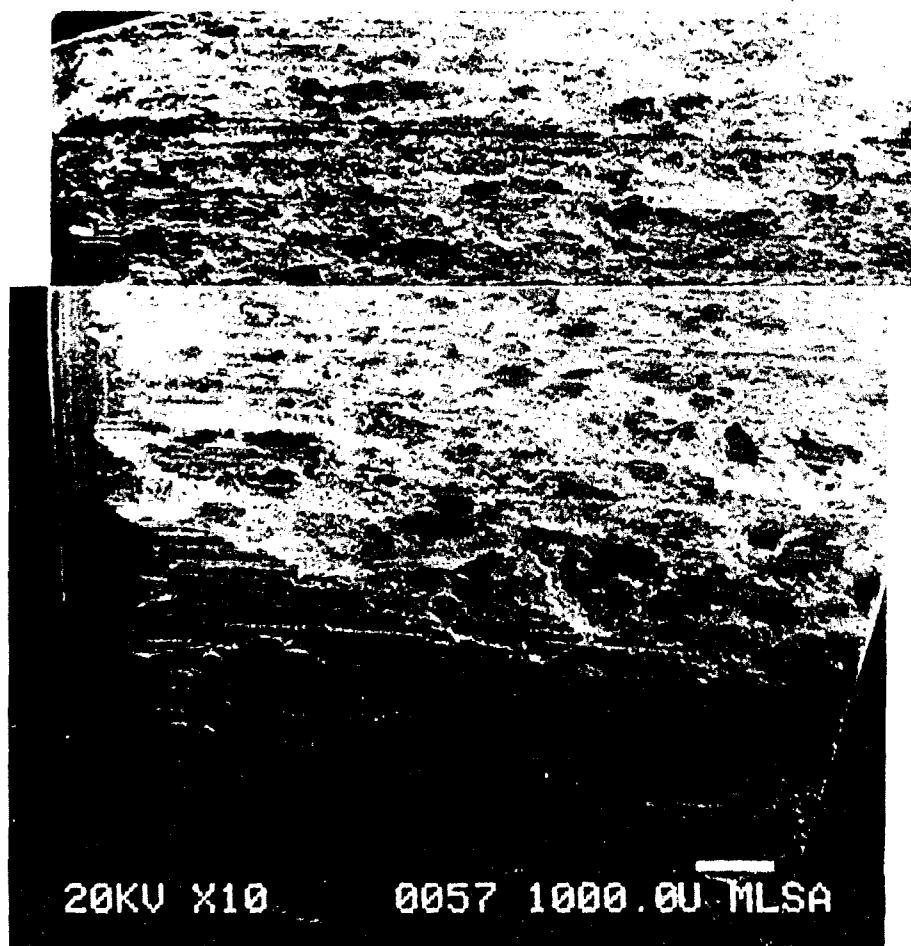
Figure 4.12 SEM Photograph of Pad After Bench Test 1

c. SEM and X-Ray Spectroscopy Results Scanning electron microscopy results are presented in Figures 4.12 and 4.13. Figure 4.12 provides a 10X view of a section removed from the bearing pad. Heavy smearing, galling, and abrasion are present.

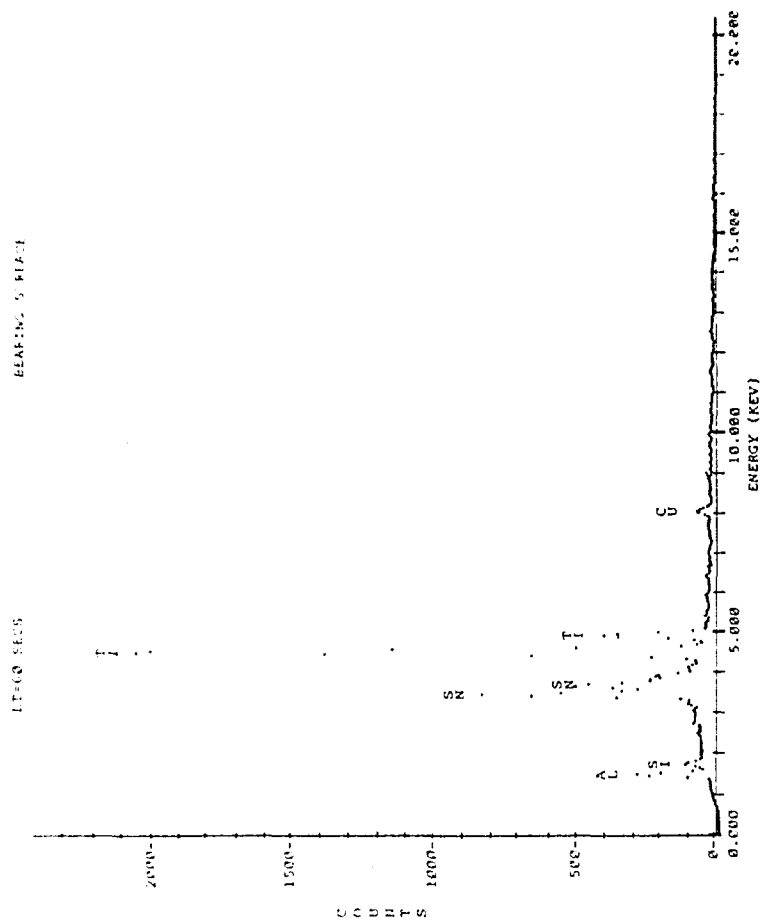
Figure 4.13a Smeared Failure Zone

Figure 4.13 provides a closer look at some areas in Figure 4.12, as well as element identification of the surfaces. Figure 4.13a shows one of the heavily smeared areas. X-ray diffraction results show a large titanium peak, as well as tin, aluminum, silicon, and copper peaks. Figure 4.13b shows one of the flaked areas. Again, a large titanium peak is evident, along with tin, aluminum, silicon, and copper peaks. The bottom, left corner of Figure 4.13b shows a pit created by galling. Figure 4.13c is a photograph of this area. The magnification reading and scale printed on the photo should be disregarded. Titanium is the predominant peak of the element identification.

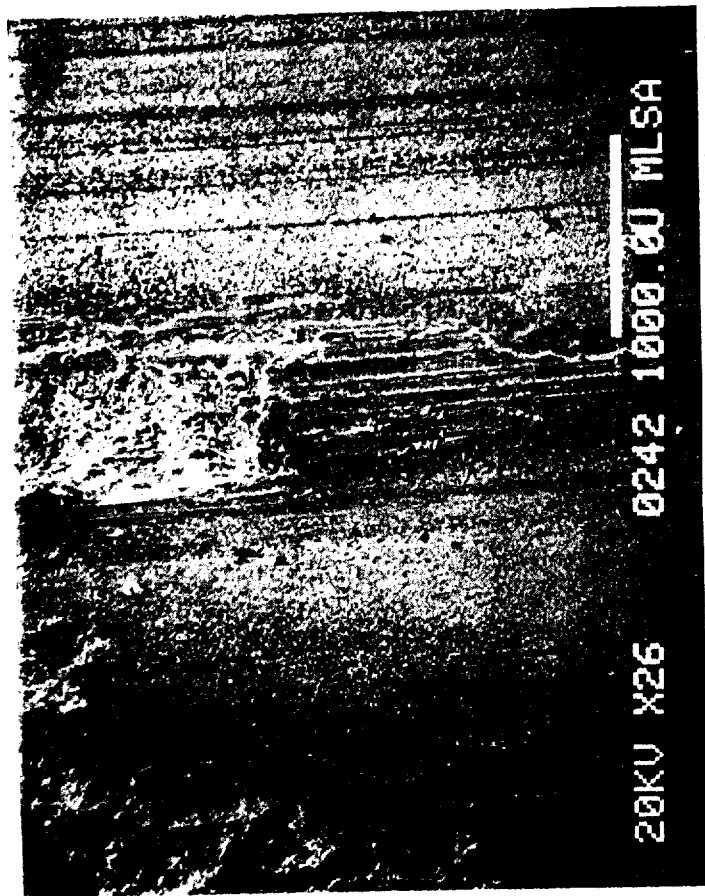
Figure 4.22a Wear Scar Beginning

Figure 4.22 shows the SEM examination of the surface of a wear scar at its beginning and end and the corresponding elemental identification. Figure 4.22a shows the beginning of the wear scar. The direction of collar movement across the surface is upward. At the very bottom of the photograph, at the entrance to the wear scar, is a wear groove approximately 0.015 inches wide. This is indicative of a wear or foreign particle initiating the scar. Two zones are evident on the wear scar; a zone of smeared metal, followed by a zone of galling. Figure 4.22b shows a closeup of the smeared zone. Results of mass spectroscopy of the area are shown adjacent. High titanium and tin peaks are evident. Figure 4.22c shows a closeup of the galled zone. Titanium is more prevalent here than in the smeared zone. Figure 4.22d shows the scar end. There is not an exit groove for a wear particle indicating that the wear or foreign particle did not exit. No wear or foreign particle was found in the scar. The scar end is characterized primarily by galling. Figure 4.22e shows a closeup and the corresponding elemental identification. This area is identical in composition and structure to the galled zone at the scar entrance.

Smearing of the material on the pad is evident in the SEM results from bench tests 1 and 3. The photograph in Figure 4.22a show that the debris created by galling was carried around by the titanium collar rotation back into the scars. This debris was smeared into the scar. This may be the reason for the intermediate frequency found in test segments IV and XI, although there is not enough evidence to prove this. Other possible explanations for this intermediate frequency may lie in the removal and reconstruction of oxidized layers in the titanium, or it may be a result of the galling mechanism.
